Manhole Inspection Summary

Manhole # S35C__053MH

Insp Date: **8/5/08 10:03 AM**

Location Address: **rear 401 n charles st**

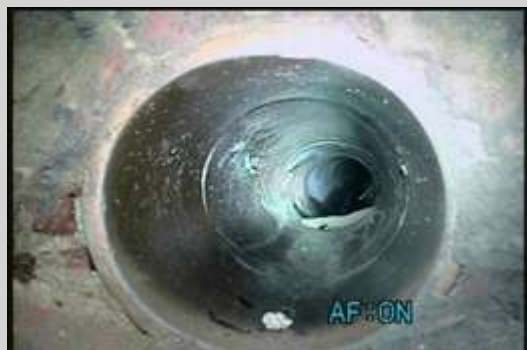
12 O'Clock Outflow

10 in. Circular Gravity Sewer
Pipe Out @ 12 O'Clock

Infiltration: **None** Pipe Seal Cond: **Unknown**
